A pitch trimmer can cause a catastrophic structural failure in an aeroplane, but this is avoidable.

GB Gratton, *A pitch trimmer can cause a catastrophic structural failure in an aeroplane, but this is avoidable*, Aeronautical Journal, Vol123 No.1260 pp174-190 (Feb 2019) DOI: 10.1017/aer.2018.157

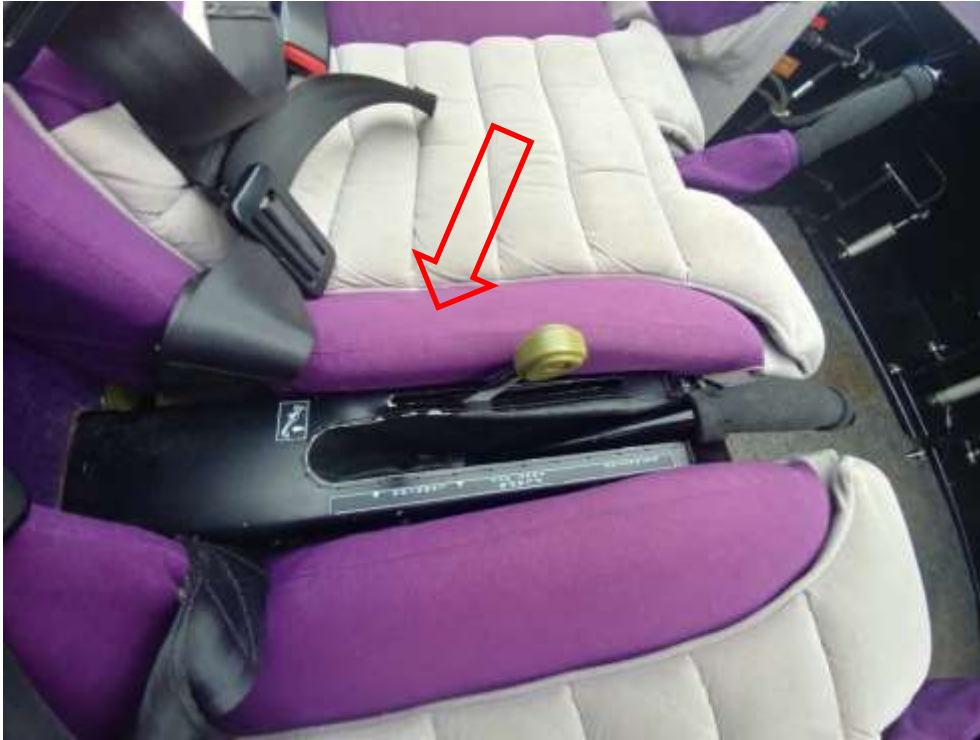
Figure 1. Pitch trim lever in Eurostar

There are several systems in use in light and microlight aeroplane cockpits to control the pitch trim function (most smaller aeroplanes not using roll or yaw trimmers – although of this sample the Bulldog does have a yaw trimmer); the most common is a trim wheel (Figure 2) necessitating relatively slow action from the pilot to make inputs; many microlight aeroplanes and sailplanes have trim levers and a few light aeroplanes, whilst examples of all aeroplane classes may use electric trimmers. Again most commonly (and the case for all aeroplanes tested here) cables will then operate a trim tab set into the elevator. The pitch trim control is always used to set the hands-off flying speed of an aeroplane, the normally taught method of use being to make that change initially with the primary pitch control (the yoke, or stick) and then to use the trimmer to remove the applied force at the primary control until that may then be released.

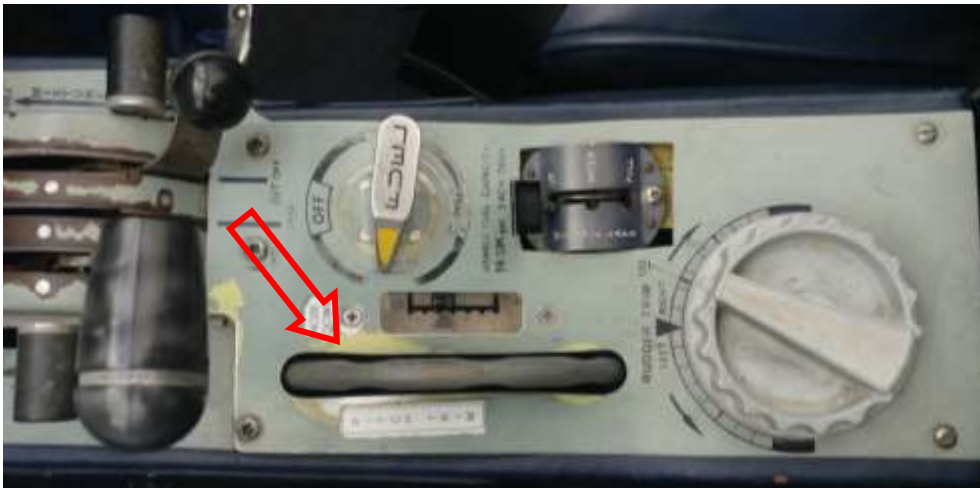
Figure 2. Pitch trim wheel in the Bulldog (located between the seats, front of aircraft is to the left of the image, wheel on right of image is yaw trimmer)

The author was unable to find previous discussion of this issue, although the fact that the vast majority of part 23 aeroplanes use a slow-moving trim wheel (such as that in Figure 2) suggests

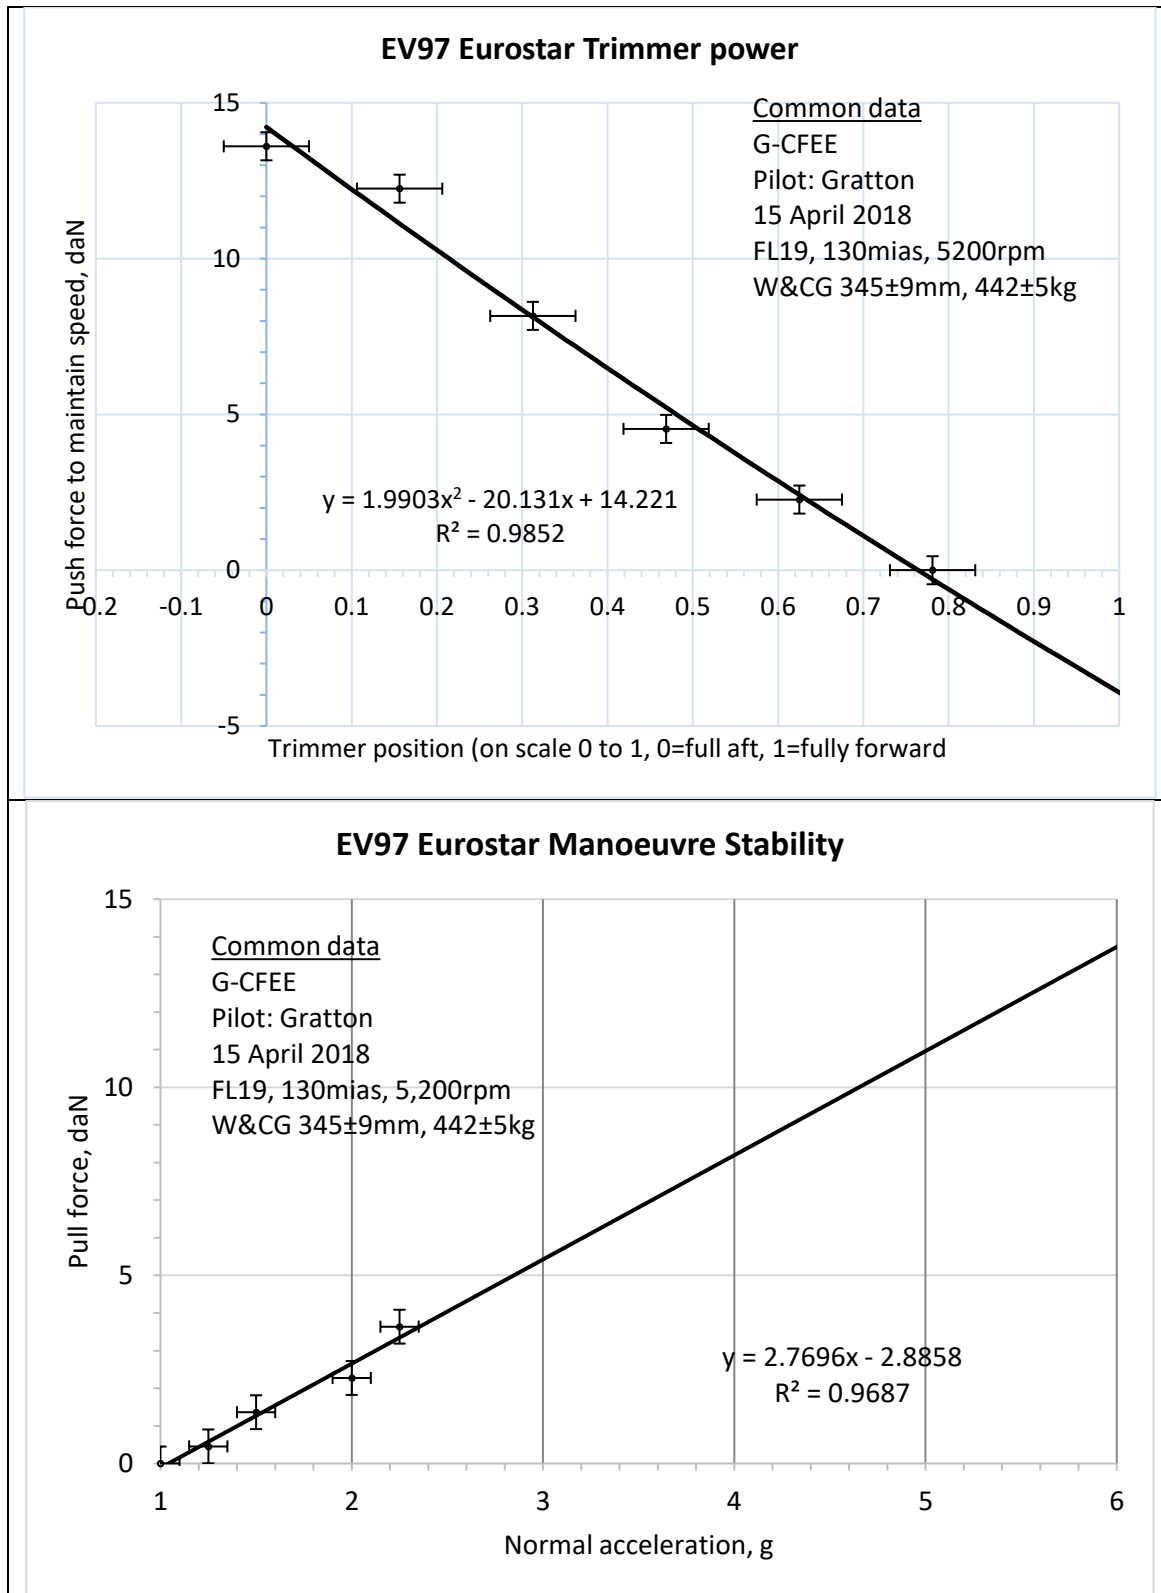
3.2 Data for the Eurostar, which was tested at 1,900ft sHp, $V_H=130\text{mias}$ (109kCAS), 5,200rpm (using 5 minute power: maximum continuous power and thus V_H are somewhat lower) are shown in Figure 3. The pitch control force (stick force) to exceed N_1 in the EV97 at the test condition was about 8daN, and to exceed this plus the standard 50% structural safety factor between limit and ultimate loads was 14daN. The stick force to maintain flight speed at the test condition, if the pitch trimmer was deflected suddenly fully nose-up (to the back stop) was about 14 daN.

Figure 3, Results for the EV97 Eurostar

The first figure is clearly approximated, since to conduct a fully representative test would be unsafe, but this indicates that a sudden full-rear deflection of the pitch trimmer would almost certainly cause the aeroplane to exceed N_1 and shows significant potential to meet or exceed the ultimate load.

The impact of simulated step trim inputs were evaluated on a different EV97 Eurostar G-CEAM at mid-fwd (303-313mm) CG position and 370kg / 83% MTOM. From V_H (trimmer position 0.73, 108kCAS, 4,000ft sHp), the trimmer was deflected, in the nose-up sense, in successive tests to positions 0.68, 0.63, 0.59, 0.54 and 0.5 whilst holding the aeroplane on condition using the primary pitch control. The pitch control was then released, thus simulating a step trimmer input. The results are shown in Table 3; these results specifically for maximum normal acceleration match closely the results for the other aircraft in Figure 3.

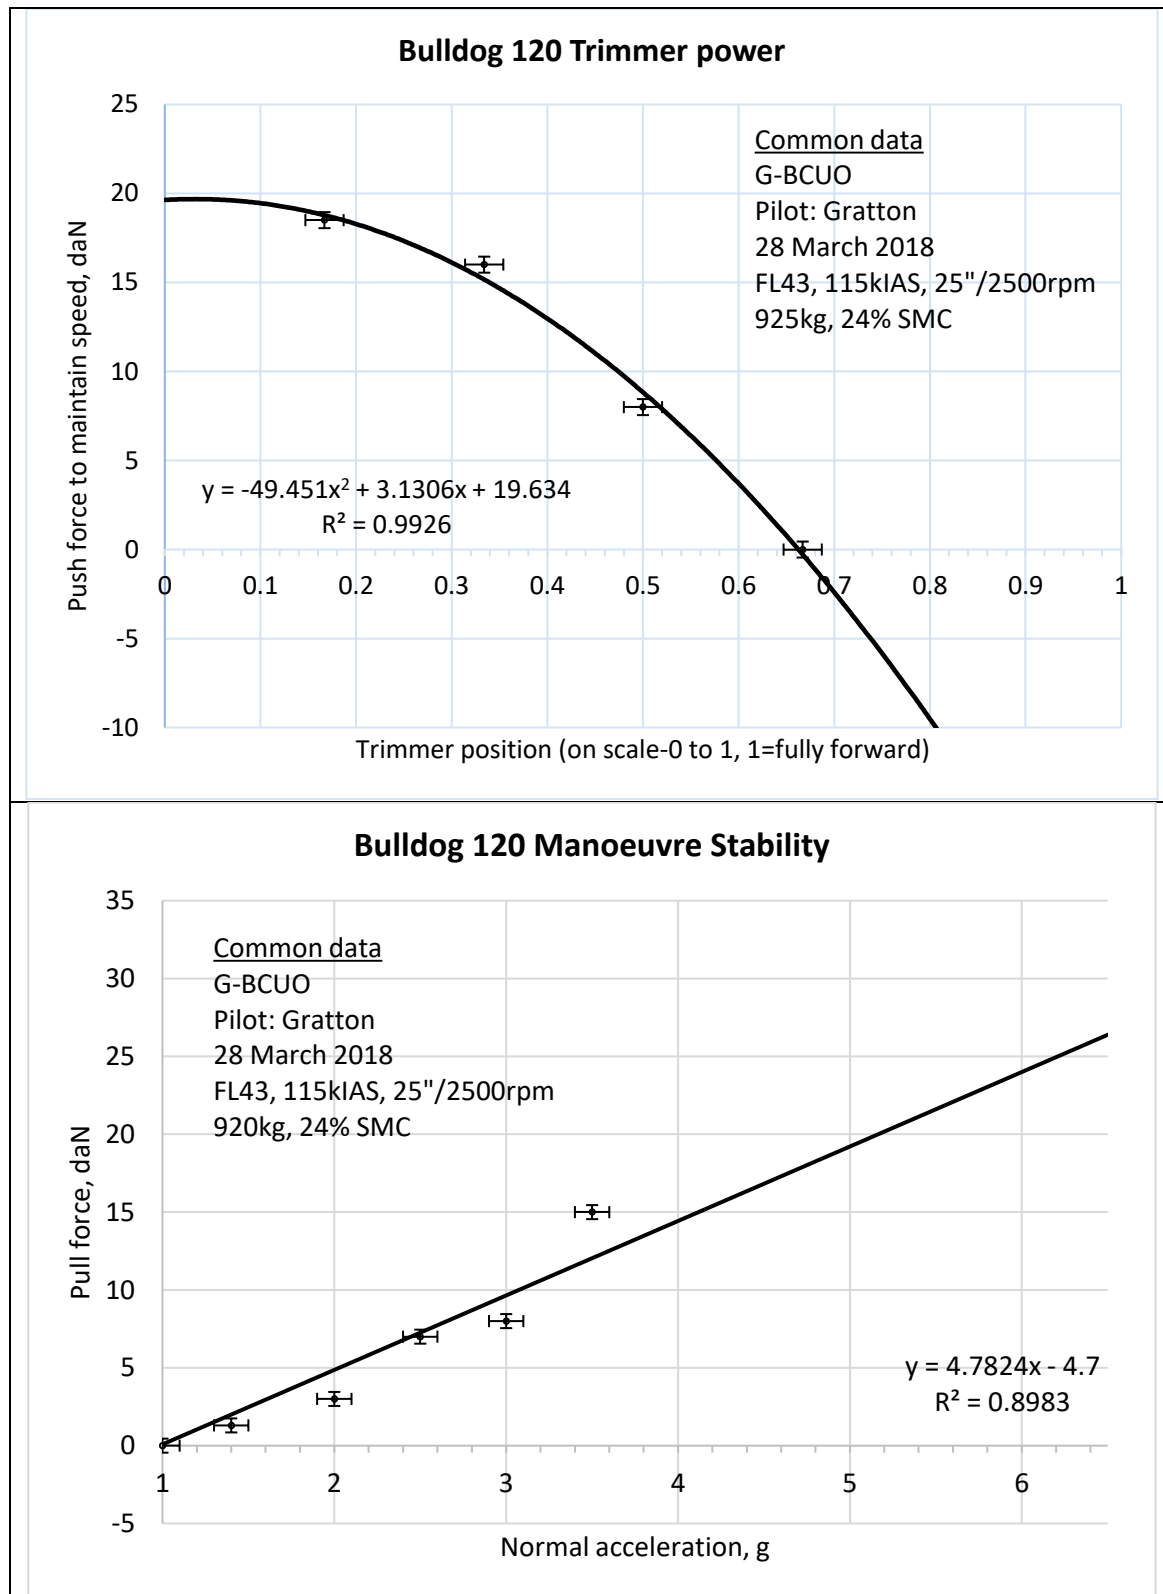
3.3 Data for the Bulldog, which was tested at 4,300ft sHp, $V_H=115\text{kias}$ [114kCAS], 25" MAP, 2500rpm are shown in Figure 4; using a quadrilateral fit to the trim authority data and linear to manoeuvre stability this indicates that a sudden full nose-up trim input (which would not actually be

possible due to the nature of the control) would create the equivalent of about 20 daN, which in turn would create a normal acceleration of about 5g. This is within the 6g aerobatic limit for the aeroplane, and thus whilst it would be dramatic, would not risk structural failure. It does seem not unlikely however that at a higher weight where the normal acceleration limit reduces to 4.4g, a structural limit might theoretically be exceeded, if the trim control permitted such an input.

Figure 4, Results for Bulldog 120

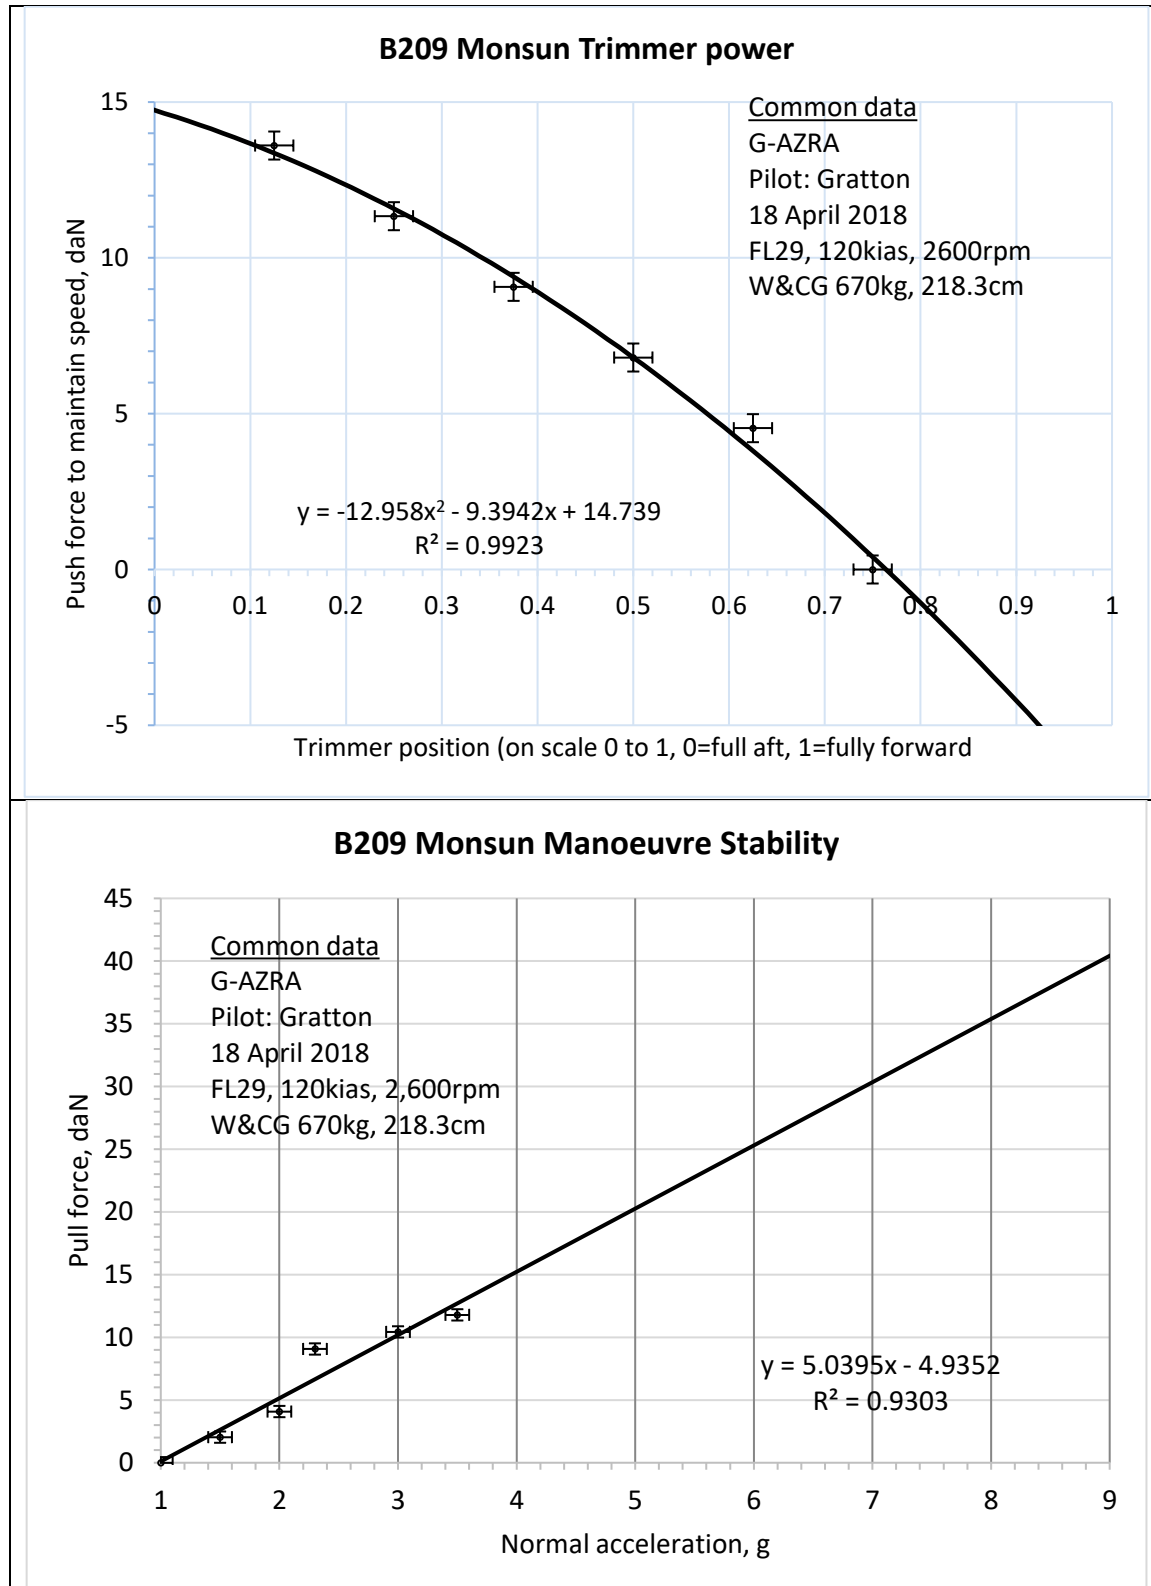
3.4 Data for the Monsun, which was tested at 2,900ft sHp, $V_H=120\text{kias}$, 2,600rpm is shown in Figure 5; using a quadratic fit to the trim authority data and a linear fit to the manoeuvre stability data. This indicates that if it were possible, a step fully nose-up trim input would be equivalent to about a 15daN sudden back-stick pressure. This in turn would create a normal acceleration about 3.4g, well within any structural limits.

Figure 5, Results for Bölkow B29 150FF Monsun

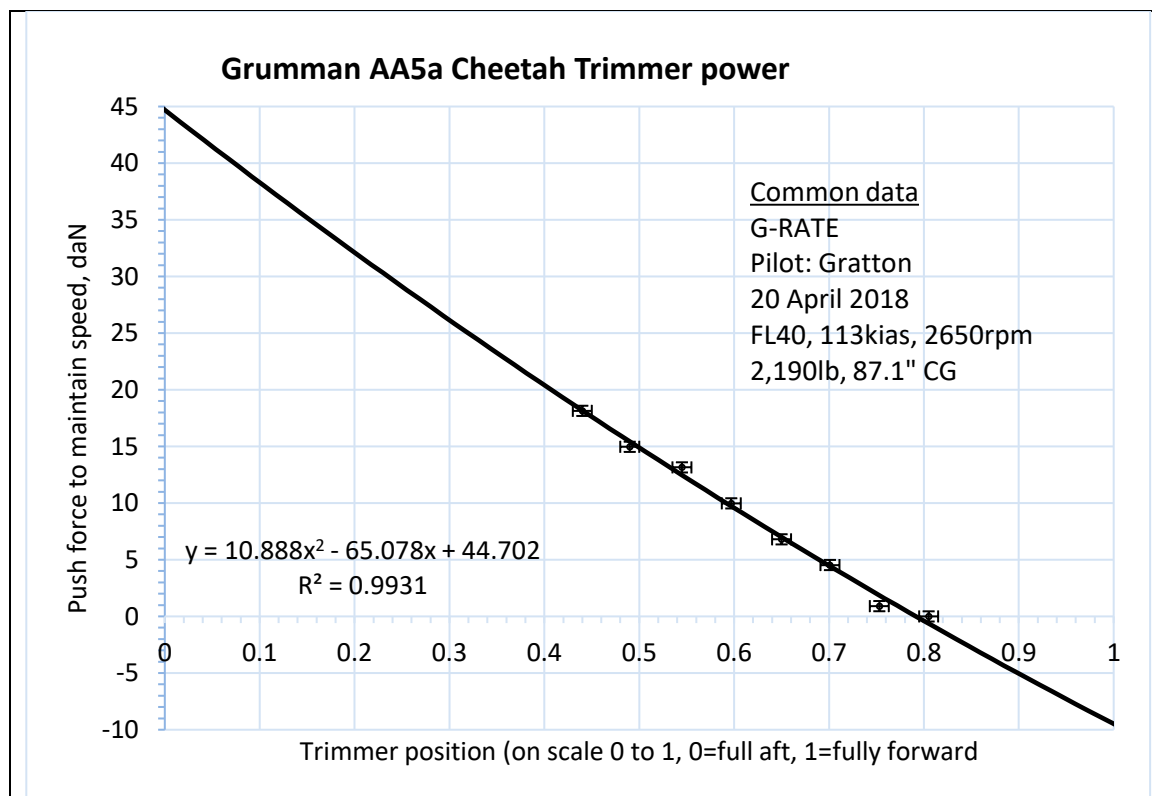
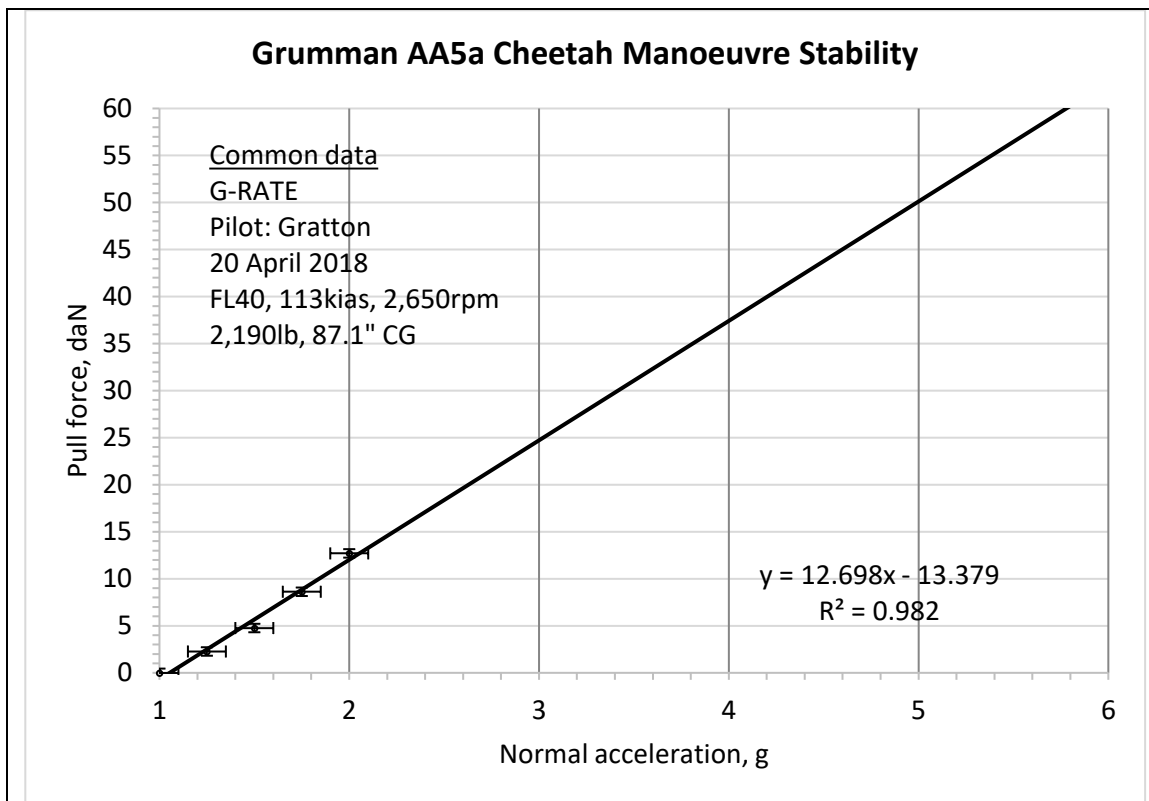
3.5 Data for the Grumman AA5a Cheetah, which was tested at 4,000ft sHp, VH=113kias [114kCAS], 2,650rpm are shown in Figure 6; using a quadratic fit to the trim authority data and a linear fit to the manoeuvre stability data. This indicates that if it were possible, a step fully nose-up trim input would be equivalent to about a 45daN sudden back-stick pressure. This in turn would create a normal acceleration about 4.5g, which is above the aeroplane's 3.8g operating limit. However, the trim wheel required about 15 turns to move from the initial setting to the theoretical full back stick condition which was then tested on the ground and required about 11 seconds of vigorous input, during which period, in the air, aircraft flight conditions would change, including significant reduction in airspeed. Therefore the aeroplane is protected by the nature of trim inceptor mechanisation, without which there might be a problem with this aeroplane – this is explored further in section 6.

Figure 6, Results for Grumman AA5a Cheetah

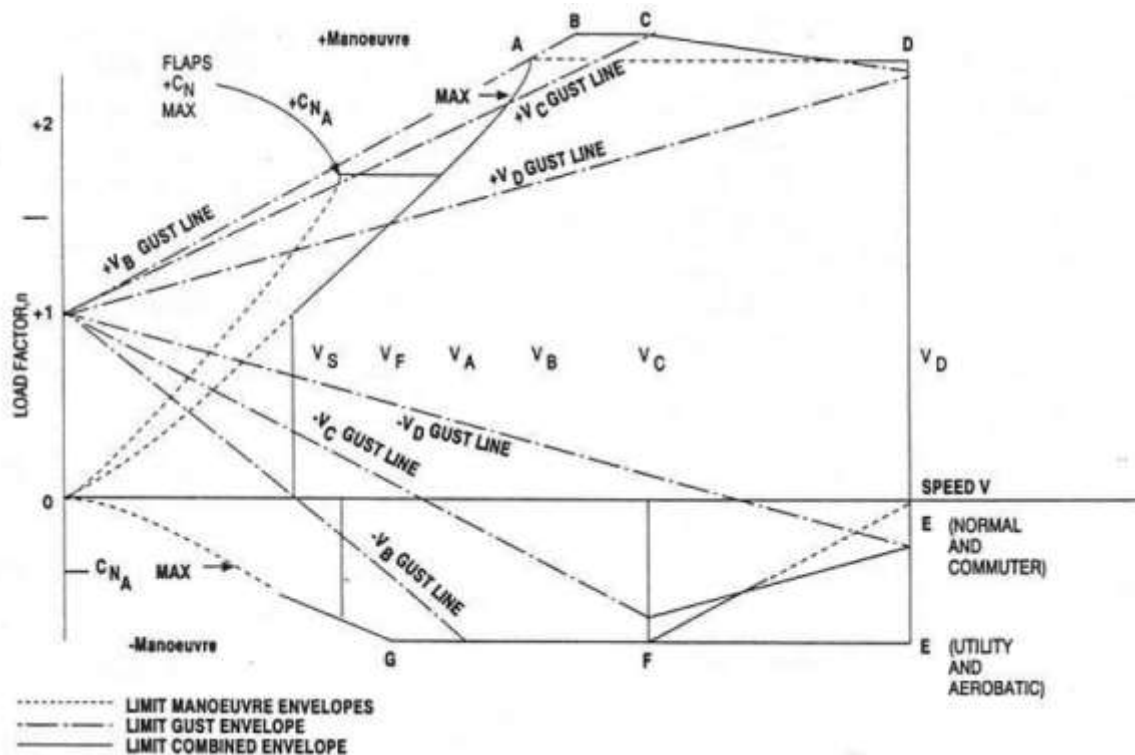
It is well known that the O-A portion of the classic V-N diagram “flight envelope” as shown in Figure 7 is supposed to prevent an exceedence of N_1 so long as an aeroplane is kept below V_A^0 ; the protection mechanism is that the aeroplane should stall before structural limits are exceeded. Very high pitch rates will most likely delay the onset of the stall, however there is also a 1.5 safety factor (or greater) in most aircraft between the authorised flight envelope and ultimate conditions, and also airworthiness standards normally require that ultimate conditions can be withstood for at least 2 seconds without any permanent deformation; hence that protection should remain.

Figure 7, Typical basic flight envelope diagram (from CS.23¹⁰ - an applicable airworthiness standard for the Bulldog, Monsun and AA5a); apart from numeric limits, these diagrams do not vary significantly between airworthiness standards and this may be considered to apply equally to smaller (e.g. CS.VLA¹¹) aeroplanes, as well military aeroplanes. Microlights such as the Eurostar, unless relatively high performance, are certified in its entirety to BCAR Section S¹³ and will not consider gust loadings which, in any case, are irrelevant to the O-A curve. Whilst this figure faithfully replicates the figure in CS.23, in fact V_S on the O-A curve is at 1g and V_A is at N_1 (typically 3.8g – 6.0g).

Above V_A this protection does not exist, and aircraft are reliant upon a combination of piloting skill and judgement preventing overstress, and the extant safety factors. Generally experience shows that this strategies are adequate – however it is definitely true that many aeroplane types can exceed V_A in level flight, and virtually all aeroplane types can exceed V_A in a dive.

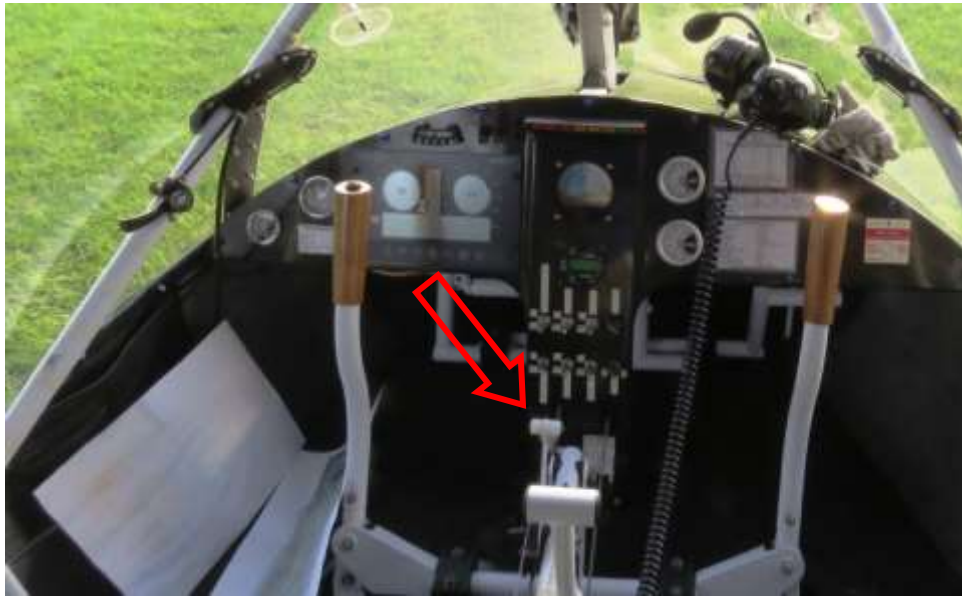
Figure 10. Location of the pitch trim control lever in a Raj Hamsa X'Air cockpit (lever nearer camera is a throttle, black lever on left hand cockpit frame is an engine choke control).

The phrase “proper precautions must be taken to prevent inadvertent, improper or abrupt trim tab operation.” might reasonably be interpreted as prohibiting the use of a powerful trim tab lever that is located between seats where it might be accidentally operated. However, the author was unable to find any evidence that this interpretation has historically been considered – for example the X’Air microlight aeroplane, which has an excellent safety record has such a trim lever, albeit further forward in the cockpit (Figure 10). Reviewing certification reports for the X’Air it has a stick force/g of about 2.5 daN/g and nose-up pitch trimmer authority capable of trimming down to the stall, but is unable to sustain level flight above the V_A of 65kCAS¹⁴, which would presumably provide good protection from overstress due to a step nose-up pitch trimmer input, as would the relatively forward position of the trim lever.
